AG-AVT-140

Corrosion Fatigue and Environmentally Assisted Cracking in Aging Military Vehicles

Published March 2011

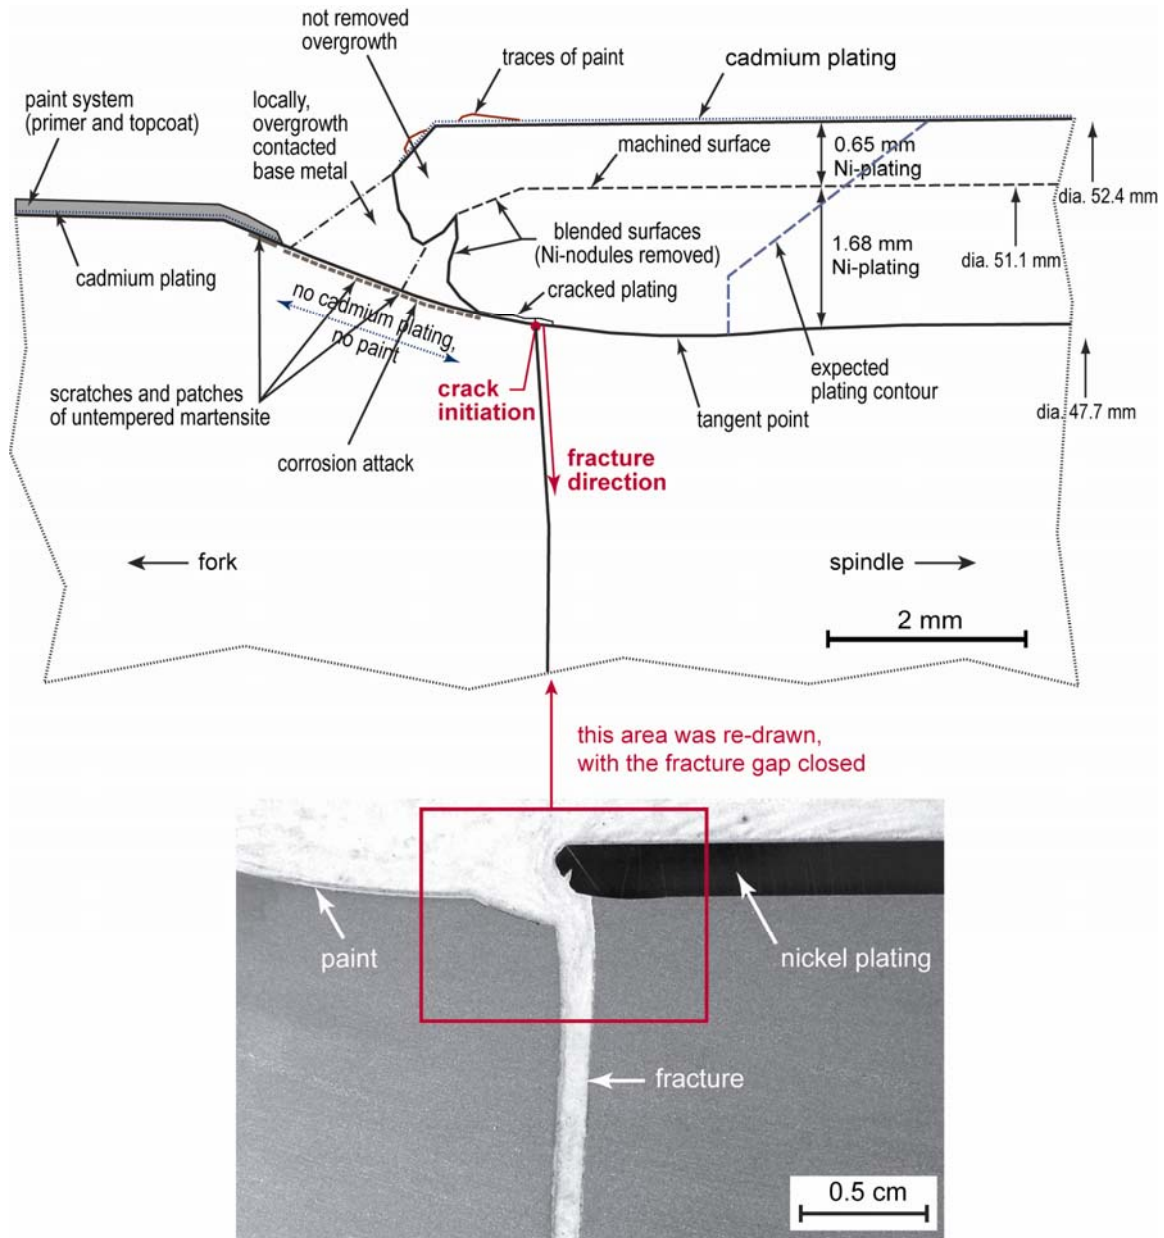
Figure 20-26 summarises the metallographic observations in a detailed sketch that schematically rejoins the fracture surfaces. This sketch clearly shows the extent of the unprotected, and hence corroded, steel surface.

Figure 20-26: Case History 20.5.3 – Summary of the Metallographic Observation.

The repair history will be reviewed with the aid of Figure 20-26. Initially, corrosion removal required machining the spindle to below the minimum repair diameter. However, the OEM issued a directive to allow repair by nickel plating and installing a sleeve. The actual repair was done solely with nickel plating. The nickel plating was applied in two layers, each followed by baking for 23 hours. The first nickel layer was machined and blended, removing nickel nodules in the radius area. This resulted in damage to the

steel surface (tool marks, see Figure 20-22, and untempered martensite, see Figure 20-25). The second nickel layer was also machined, but the overhanging nodules in the radius area were not removed.

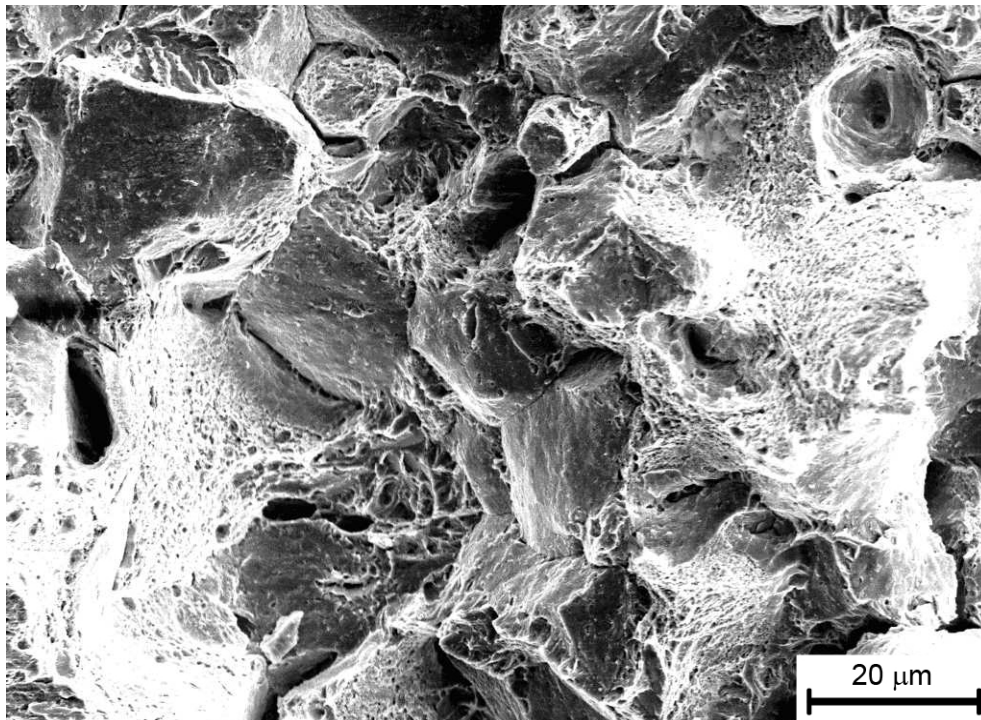
transgranular dimpled rupture, for example the SEM fractograph in Figure 20-28. This type of overload fracture has been observed for other high strength steels [6].

Figure 20-28: Case History 20.5.4 – Fracture Characteristics of the Non-Suspect Used D12 Bolt from the Pilot Tensile Tests.

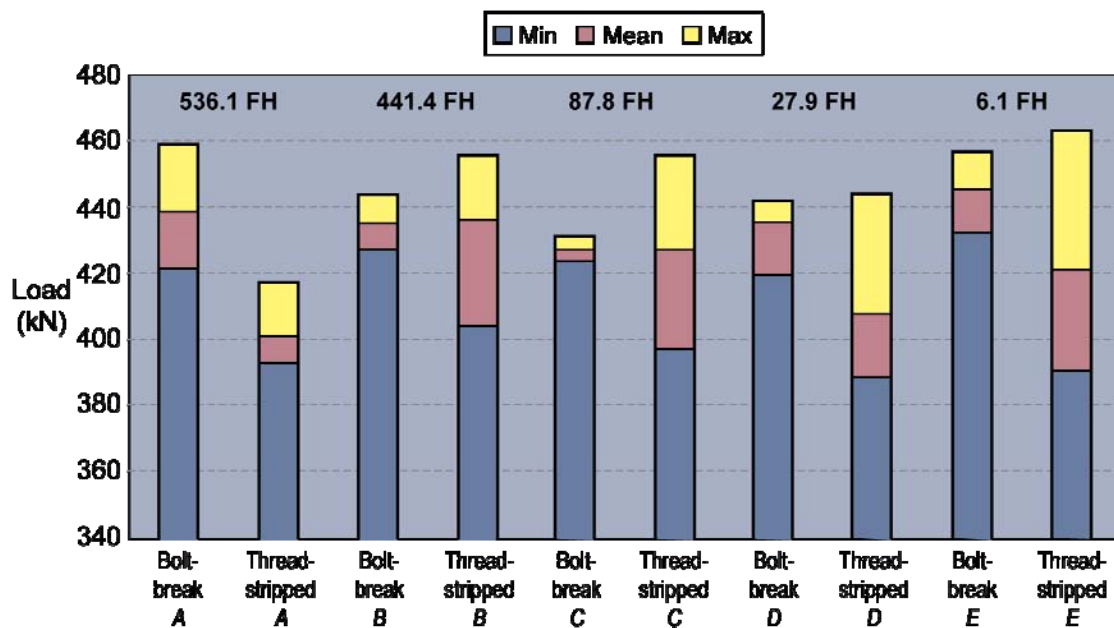
Figure 20-29 summarises the test data in a histogram. This gives the ranges in failure loads for the two failure modes, bolt-break (19 cases) and thread-stripped (31 cases). For each of the 5 aircraft the bolt-break failure mode resulted in minimum and average failure loads at least as high as those for the thread-stripped failure mode. Also, there is no apparent relation between the failure loads and flight hours since paint stripper treatment.

Figure 20-29: Case History 20.5.4 – Histogram of the Definitive Tensile Test Data (FH = Flight Hours since paint stripper treatment).

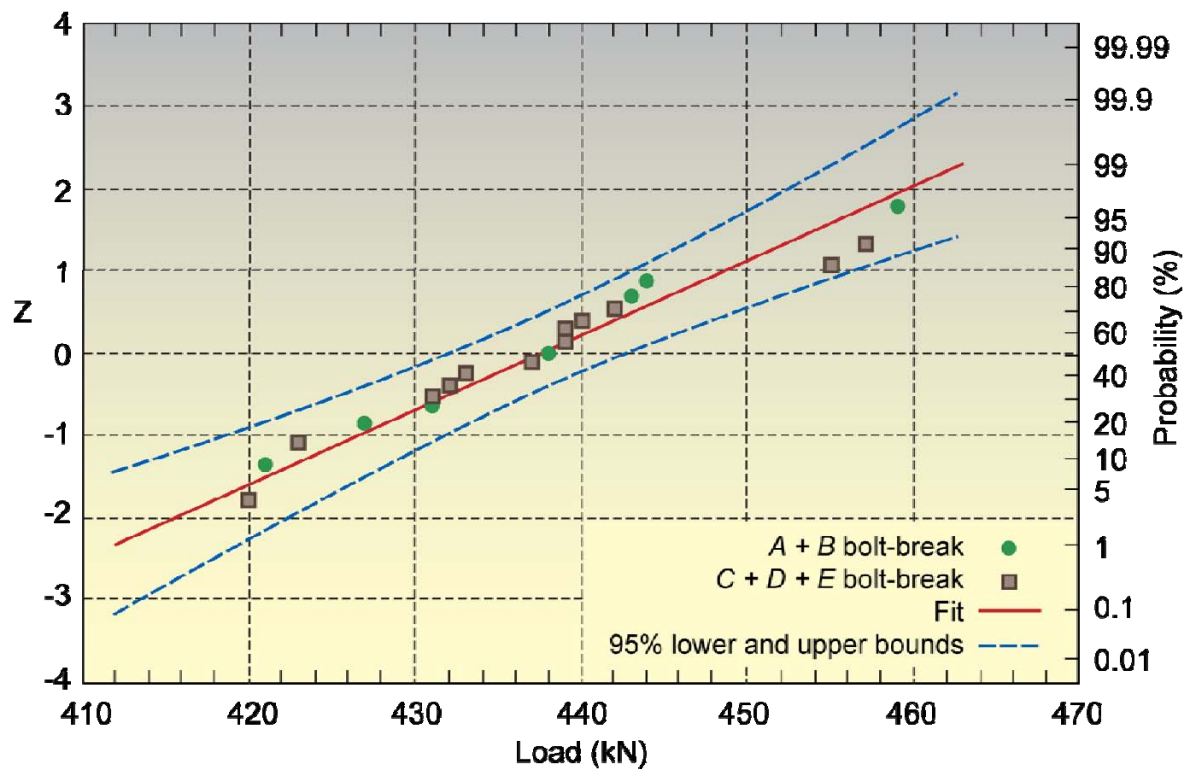
Figure 20-30: Case History 20.5.4 – Normal Fit for the Bolt-Break Failure Load Data from the Definitive Tensile Tests.

- 2) In combining data from all 5 aircraft, it can be seen from Figure 20-30 and Figure 20-31 that the bolt-break minimum and mean failure loads were well above those for the thread-stripped failures. The mean values were 437 kN and 422 kN, respectively.

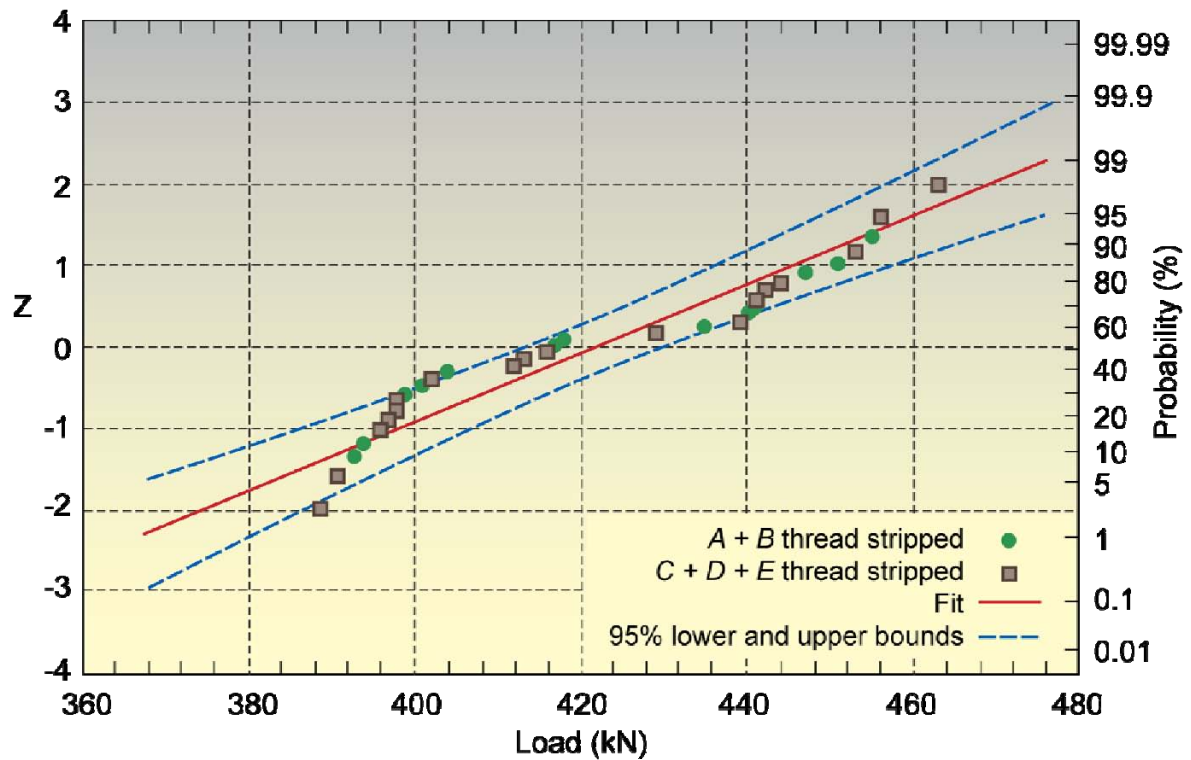
Figure 20-31: Case History 20.5.4 – Normal Fit for the Thread-Stripped Failure Load Data from the Definitive Tensile Tests.

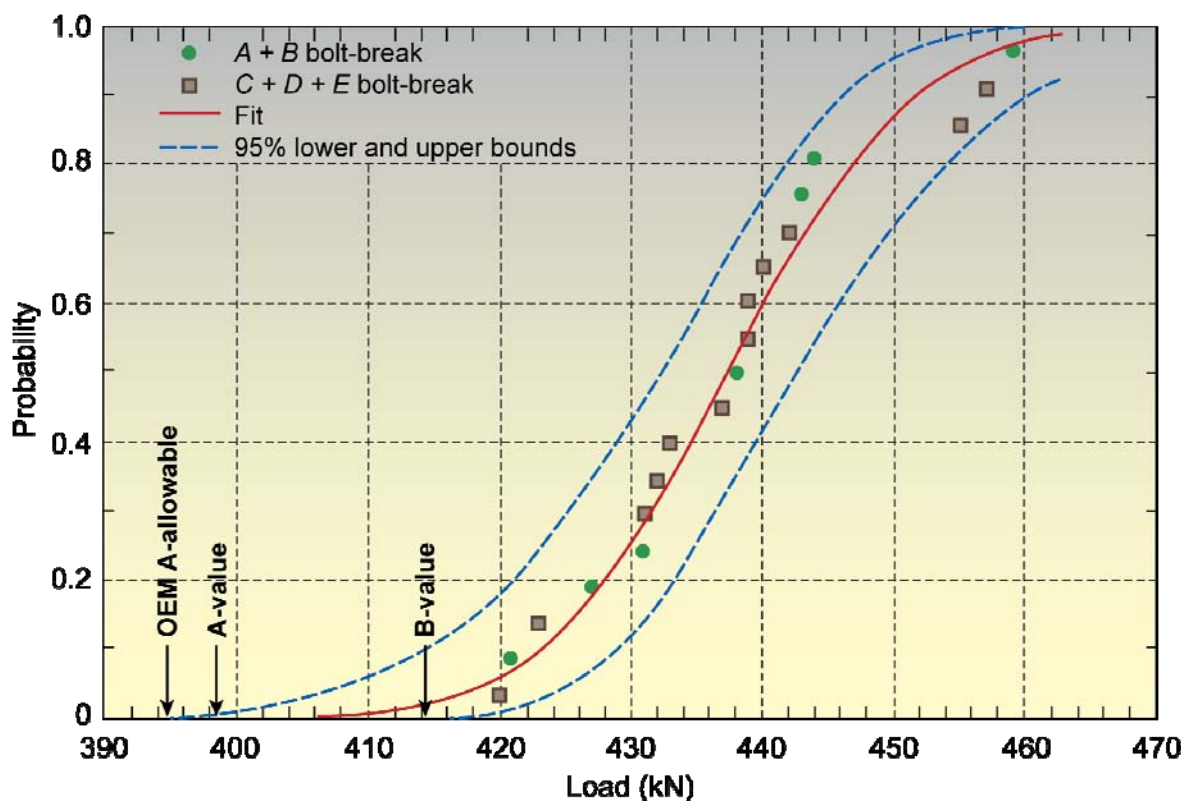
- 4) *Minimum Strength Level* – Figure 20-32 depicts the same information for the bolt-break failure data as Figure 20-30, but now in terms of a Cumulative Distribution Function (CDF), together with the failure strength A- and B-values⁴. These represent the 95% confidence lower limits on the first and tenth percentiles of the property distributions, 399 kN and 415 kN, respectively. The confidence limits were determined using the Fisher information matrix [17].

**Figure 20-32: Case History 20.5.4 – Cumulative Distribution Function (CDF)
for the Bolt-Break Failure Load Data from the Definitive Tensile Tests.**

Figure 20-32 also shows the OEM failure strength A-allowable for D12 bolts, 395 kN. The estimated A-value from the bolt-break tests is higher, even though based on a limited data set of 19 cases. One may expect the A-value for a larger data set to be still higher.

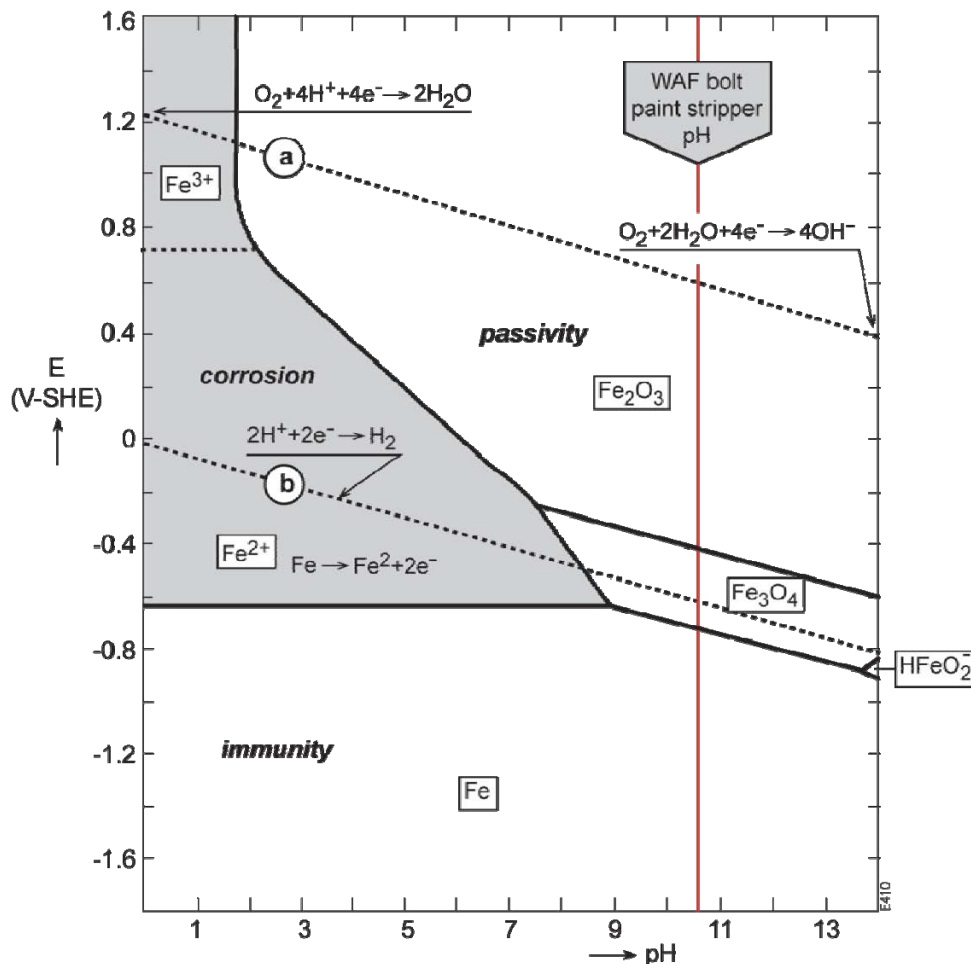
Figure 20-33 shows a simplified Pourbaix (E – pH) diagram for iron in water [18]. The two diagonal lines (a) and (b) bound the region of stability of water as a function of potential and pH. Above line (a) water is thermodynamically unstable with respect to the generation of oxygen gas. Between lines (a) and (b) water is thermodynamically stable. Below line (b) water is thermodynamically unstable with respect to the generation of hydrogen gas. Bubbles of hydrogen will evolve on a metal surface (acting as an electrode) in contact with water in this region.

Figure 20-33: Case History 20.5.4 – Simplified E – pH Diagram for the Iron-Water System at 25°C (E is the electrode potential with respect to the Standard Hydrogen Electrode (SHE)).

The pH of the WAF bolt paint stripper is shown as a dashed vertical line in Figure 20-33. Knowing that the bolts would initially be cadmium plated, and that cadmium plating is sacrificial with respect to steel, this E – pH diagram suggests that:

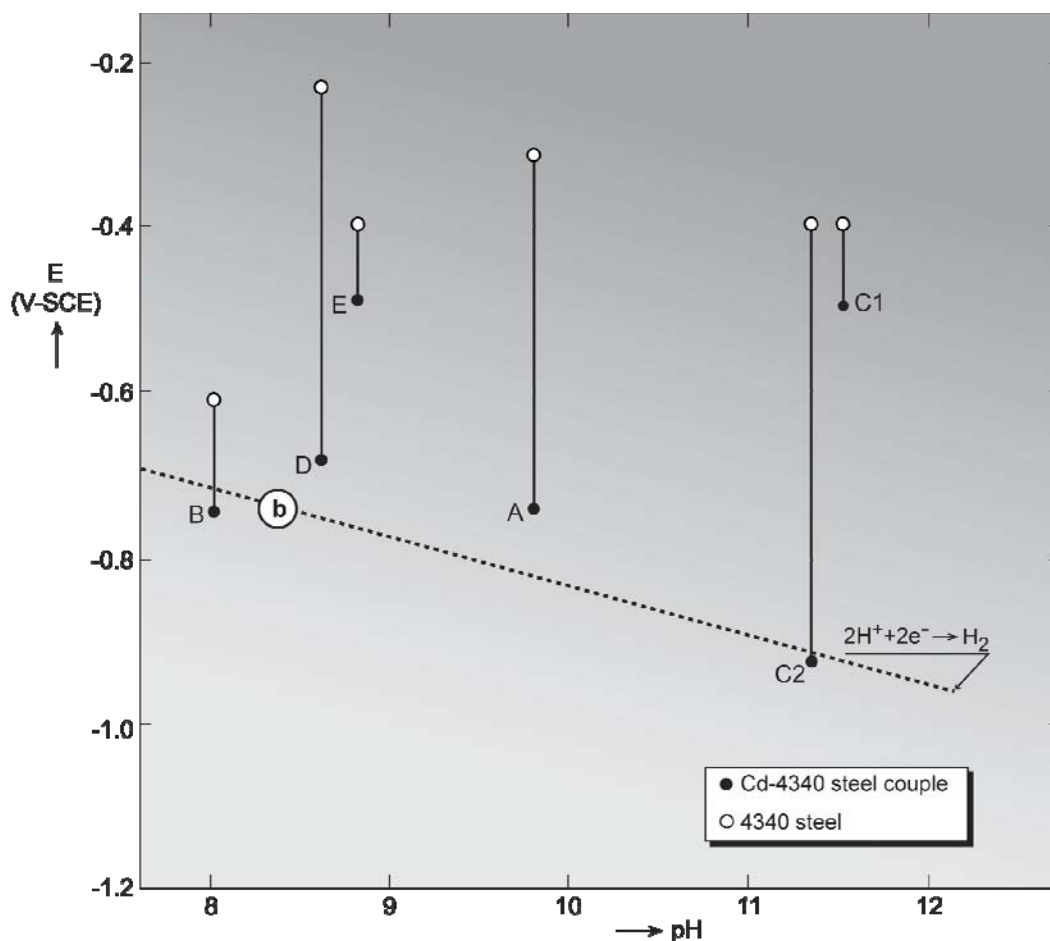
With respect to 1) above, there is the question of hydrogen absorption into the WAF bolts during the anodic attack and removal of the cadmium layer by the paint stripper. This could occur only if the galvanic coupling potential was below line (b), *as may have been the case*. For example, Figure 20-34 shows the galvanic coupling potentials for cadmium and 4340 steel in several paint strippers [19], whereby it is seen that it is possible to transgress below line (b).

Figure 20-34: Case History 20.5.4 – E – pH Diagram for (1) Open Circuit Potentials of 4340 Steel and (2) Galvanic Couple Potentials for Cadmium and 4340 Steel in Paint Strippers [19]
 (E is the electrode potential with respect to the Saturated Calomel
 Electrode (SCE): $E(\text{SCE}) = 0.241 E(\text{SHE})$ at 25°C).

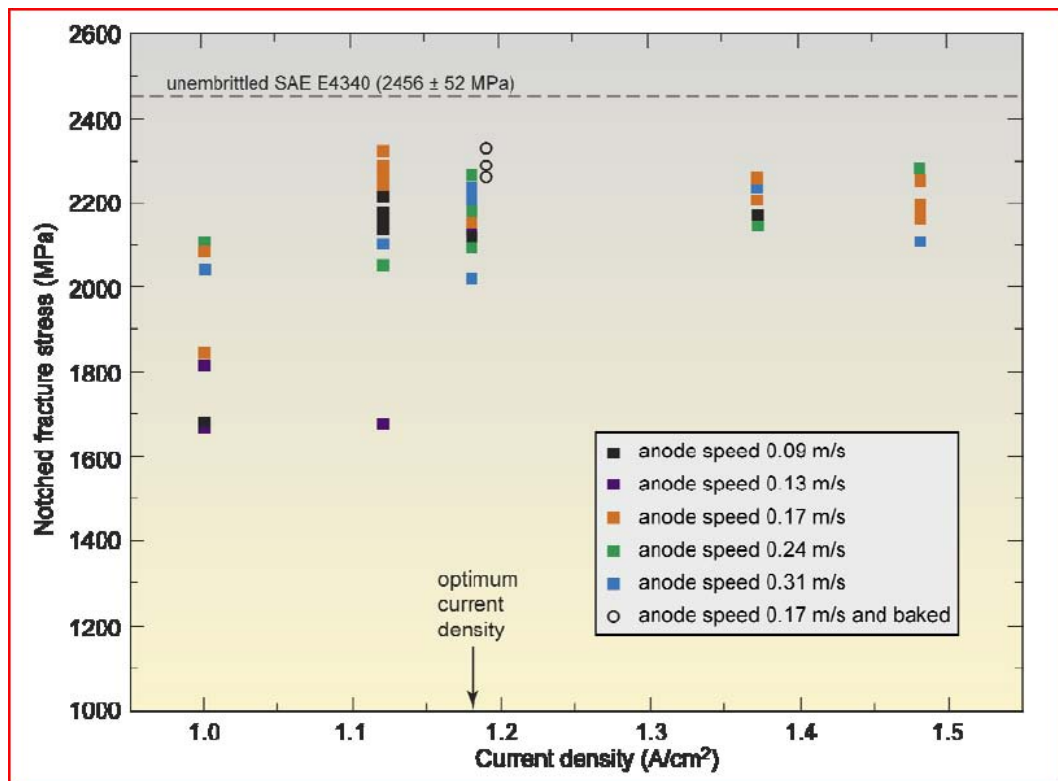
The SSRT results are shown in Figure 20-35 and Figure 20-36. The unembrittled notched fracture stress for SAE E4340 steel is also indicated (dashed horizontal line) to enable assessing the degree of embrittlement by any of the plating conditions, including the optimum conditions of plating and baking.

Figure 20-35: The Effect of Current Density in the Range Suggested by the Manufacturer on the Notched Fracture Stress of SAE E4340 Steel Specimens.

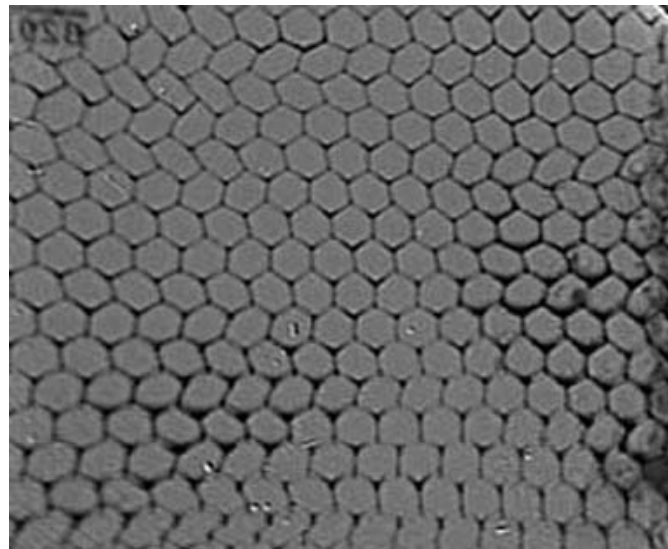
An important requirement of the radiography inspection was to visualize the resin-rich or resin-starved areas (defect types 4 and 5 in Table 22-1). These types of defects can be identified by the fact that they are clearly visible in the NR images due to the high neutron attenuation coefficient of hydrogen containing materials, while for X-ray radiography they are not visible. This is illustrated in Figure 22-9 which shows a resin-rich area in the honeycomb structure detected by NR. Another interesting point of this image is the well-resolved double contour lines, as they reflect the tilted position of the honeycomb elements.

Figure 22-9: Dry NR Image of the Honeycomb Structure with Resin-Rich Areas (dark spots).

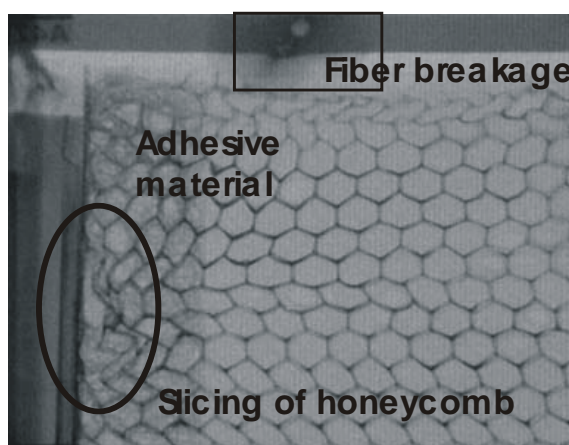
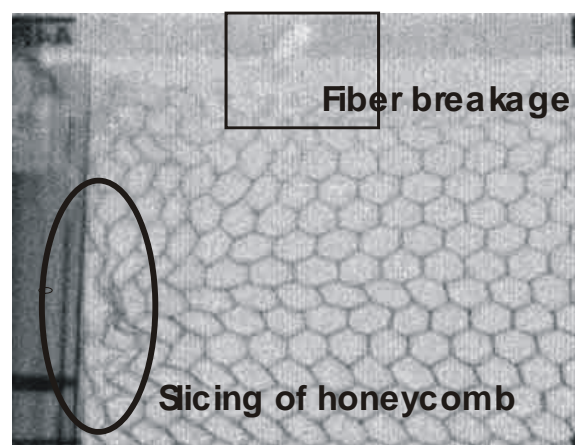
A fiber breakage (defect type 7 in Table 22-1) in the trailing edge is observable in Figure 22-10. In the same segment another type of defect was detected. Both NR and XR images show slicing of the honeycomb structure near the stiffener, however, the adhesive material can be detected only by NR. One of the most dangerous defects is when a de-bond (defect type 8) in the adhesive surface is present between the honeycomb structure and the aluminium spar. Such observations are illustrated in Figure 22-11. The double contour lines are because of the tilted position of the honeycomb elements. In this investigation one of the most important observations was the presence of cavities, holes and/or cracks in the sealant and at the border of the sections. The problems were caused by water penetrating into these places and freezing which caused damage to the surrounding structure due to the volume expansion of ice. Detection of these defects is very difficult because of the complex arrangement of the composite structure. A combination of ‘dry NR’, ‘wet NR’ and XR experiments made it possible to discover and visualize these defective areas. It was established that the most frequent locations of water penetration were at the border sections or at the honeycomb-adhesive sealant joining surfaces. These defects are visible in Figure 22-12.

Figure 22-10: (a): Fiber Breakage and Slicing of Honeycomb and the Adhesive Material Revealed by NR; and (b): Fiber Breakage and Slicing of Honeycomb and the Adhesive Material Revealed by XR.

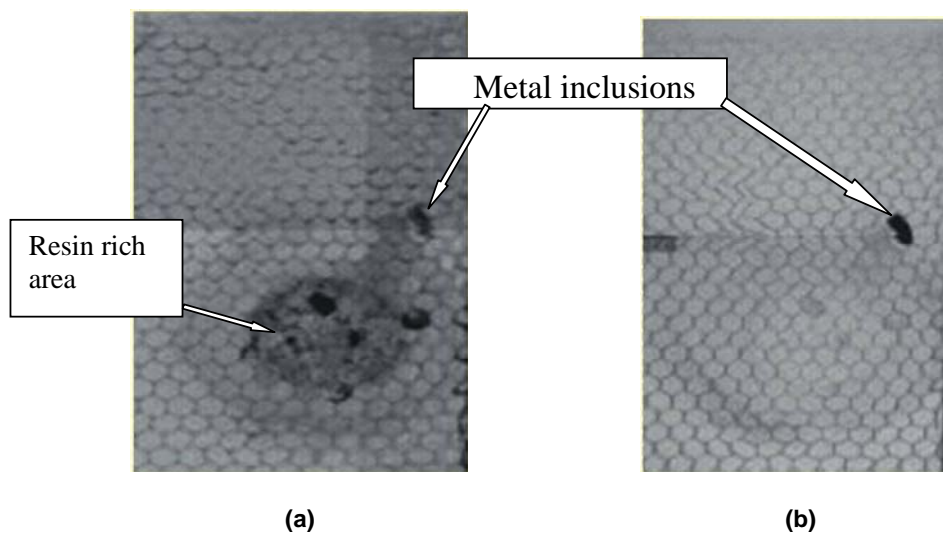
Damage caused by splinters may happen during flight missions (defect type 2 in Table 22-1). Our experience showed that such defects occurred during gunnery practice. Although these defects were usually repaired by the maintenance team, a small piece of splinter was not detected by them and thus it was not removed, as may be seen in Figure 22-13(a) NR and Figure 22-13(b) XR pictures. In the NR image the resin rich spots are seen to be as dark as the metal inclusion, while the XR image provides a dark contrast only for heavy elements with large X-ray attenuation.

Figure 22-13: (a) NR Picture of the Repaired Area; and (b) XR Picture of the Repaired Area.

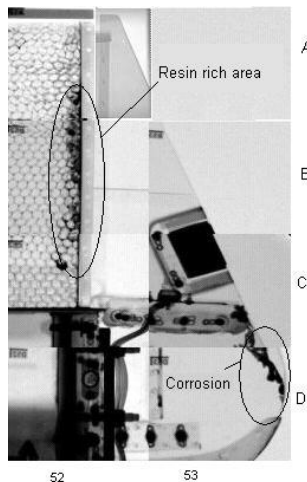
Corrosion may also cause problems, leading to possible lifetime reductions. Corrosion was detected in some of the investigated blades inside the rotor blade tail element, as shown in Figure 22-14. A resin-rich area is also shown at the bond surface of the honeycomb structure and the last stiffener. X-ray radiography is a complementary and useful tool in assessing the structural integrity of the metal parts of the blades. Figure 22-15 shows the heating element arrangements and their contacts on a blade with some corroded contacts.

Figure 22-14: NR Picture of the Corrosion Product in the Tail of the Rotor Blade.

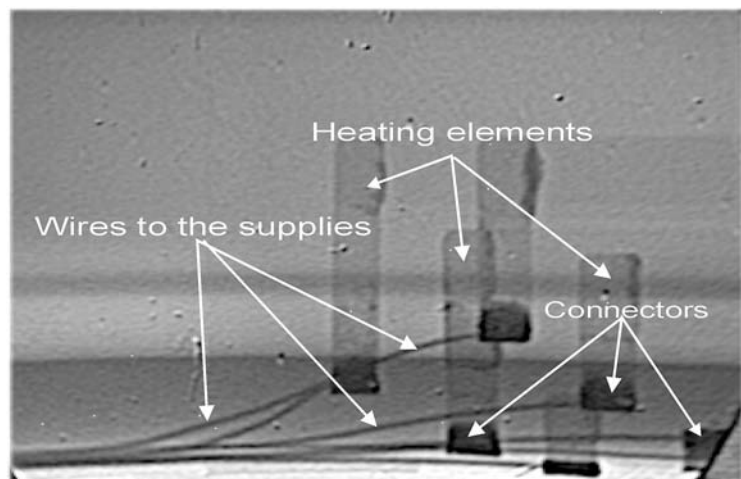
Figure 22-15: Corroded Heating Elements of the Anti-Ice Heater System Revealed by X-Ray Radiography.

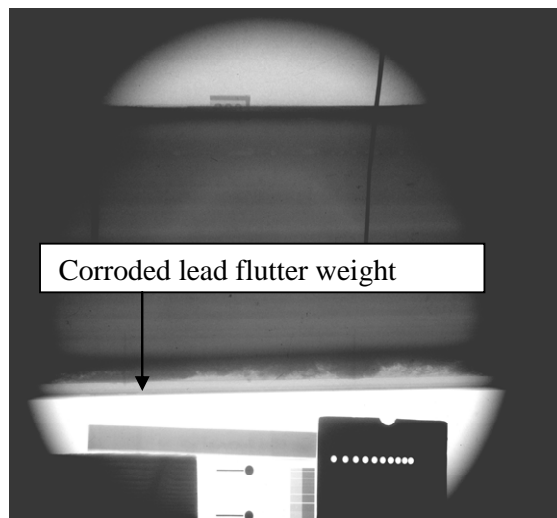
Figure 22-19: Front Edge of the Ka-26 Helicopter Rotor Blade Revealed by NR with Corrosion Products on the Anti-Flutter Weight.

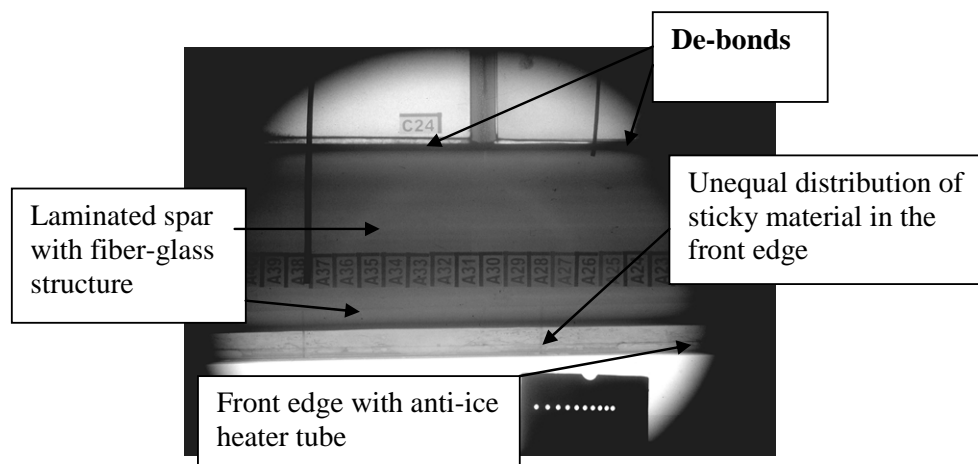
The NR picture of Figure 22-21 shows two areas of de-bond between the spar and the section. In addition one can see an unequal distribution of the sticky material on the lead anti-flutter weight at the front edge of the rotor blade.

**Figure 22-21: Spar in the Middle Part of the Ka-26 Helicopter Rotor Blade
Revealed by NR with De-Bonds Between the Spar and the Sections.**

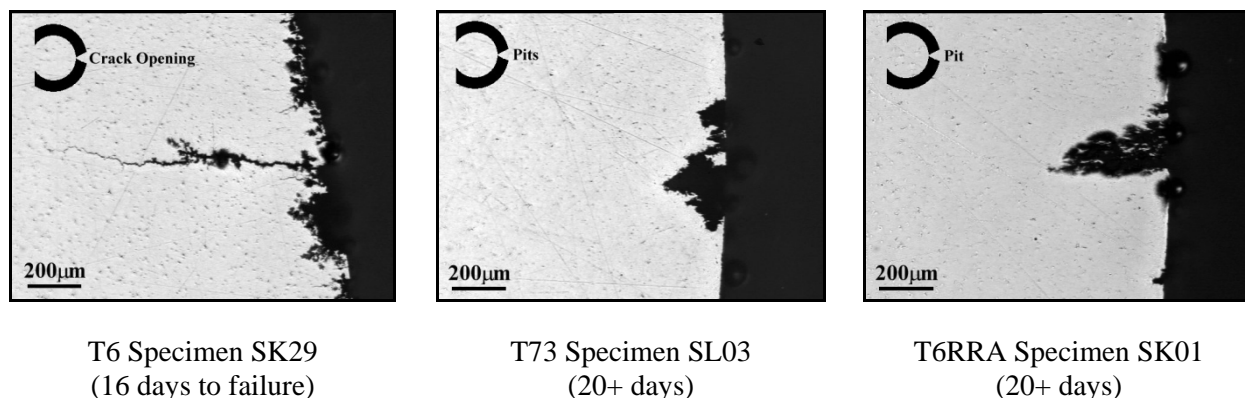
Stress corrosion cracking tests were conducted in accordance with ASTM Standards G 38 and G 44. The C-ring specimen was chosen because of the limited material thickness available in the S-T orientation. The specimens were pre-stressed to 45 and 54 ksi and placed in an alternate immersion tank where they were exposed to a 10 minute immersion in a 3.5% NaCl solution followed by 50 minutes of drying time. According to Federal Specification Sheet QQ-A-200/11E [21], the test duration is to be 20 days and specimens lasting until the end of 20 day period are considered to have SCC resistance equivalent to the T73 temper. The RRA treated specimens successfully completed the 20 day exposure period without developing evidence of intergranular cracks. Figure 25-5 shows polished x-sections of typical T6511, T73511 and T6RRA C-ring specimens.

Figure 25-5: C-Ring SCC Comparison with 54 ksi (372 MPa) Pre-Stress Level.

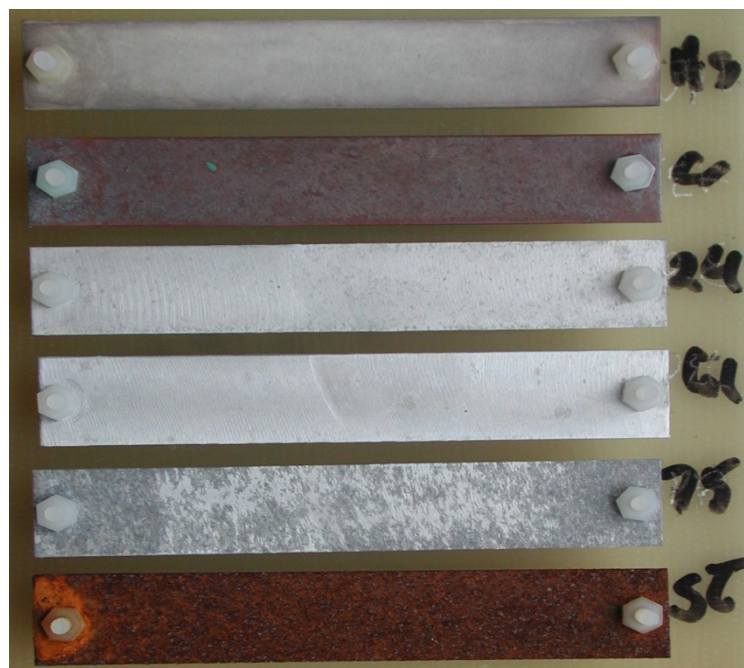
Figure 26-5: Metal Coupons Before Exposure to the Environment (a) and After a Three Month Exposure in a Rural Environment (b) (Courtesy of Battelle).

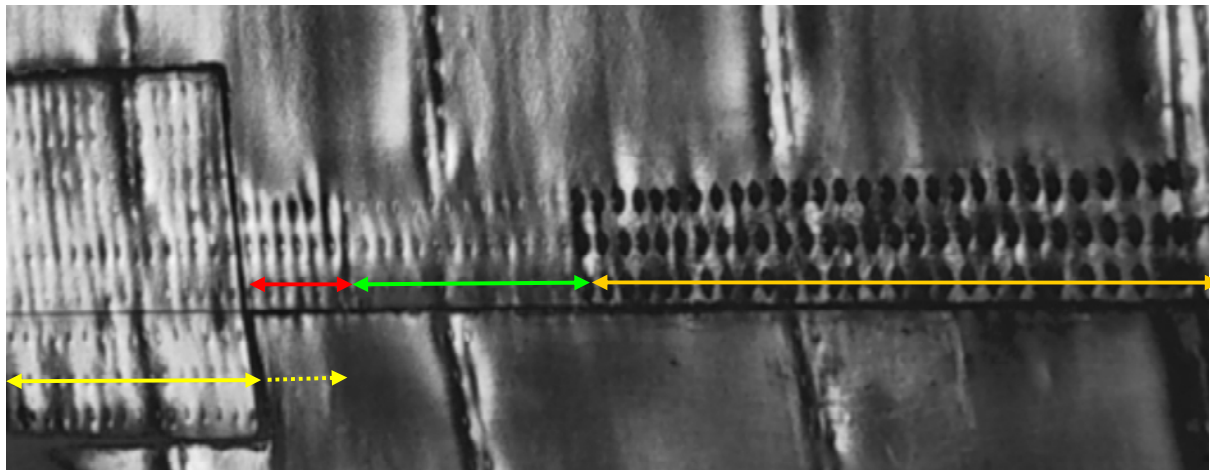
This inspection system enables enhanced visual inspections of intact joints [5]. Figure 27-1 is a DAIS image of a lap joint that illustrates the stages in corrosion growth, detection and repair:

- Red line: this area suffered un-repaired corrosion damage, visible as pillowing. Either this damage had occurred since the repairs were carried out or it was present at the time and was missed by the inspection techniques employed. At the next D-check the external doubler repair (solid yellow line) was removed and replaced with a larger doubler that covered the expanded repair area, as indicated by the dotted yellow line.

Figure 27-1: Lap Joint Corrosion and Repairs.

In the above illustration the rivet-to-rivet and row spacings in the joint were nominally equal, which caused the pillowing response when the skins were deformed by the accumulation of corrosion products between the fasteners restraining them. However, each manufacturer has invested heavily in the understanding of their proprietary joint designs and chosen specific rivet / rivet row spacings. These spacings directly affect the corrosion pillowing response and inspectability. For example, Airbus and Lockheed L1011 joints do not pillow, they make waves. Douglas DC-10 joints also make waves, but the view is complicated by the use of ‘beauty strips’ (external butt joint doublers). Douglas DC-9 longitudinal joints do not appear to pillow or make waves unless they are viewed perpendicular to the joint rather than along it as in Figure 27-1. The reason is that the DC-9 has closely spaced rivets in widely spaced rows, and corrosion product accumulation results in wave-like distortions parallel to the joint. These are almost impossible to detect when viewed along the joint.

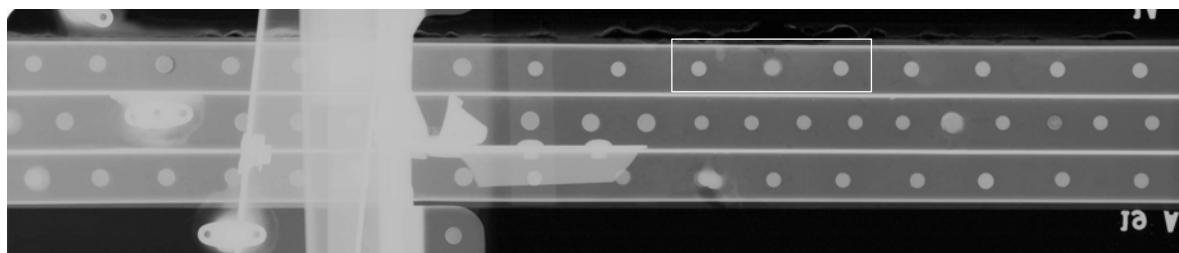
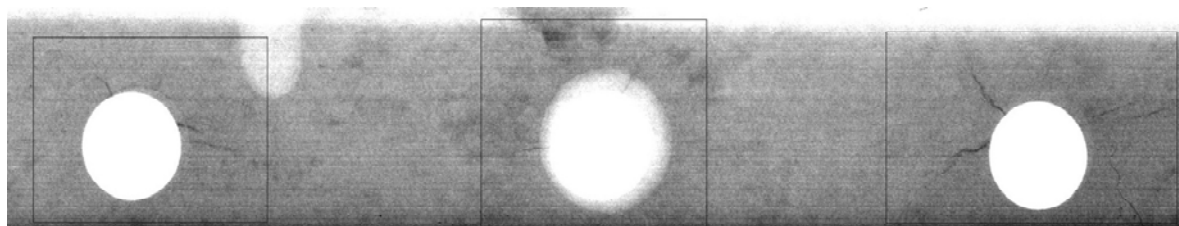
X-radiography is not typically used for corrosion detection, as is mentioned also in Part 2 of this chapter. However, the pillowing forces generated by the corrosion activity in multi-layer structures can lead to tensile forces sufficient to nucleate cracks which are detectable by X-ray, Figure 27-2.

(a) Typical x-ray film of intact joint.

(b) Non-surface breaking cracks (enlargement of area in white box).

Figure 27-2: Corrosion-Induced Pillowing Cracks.

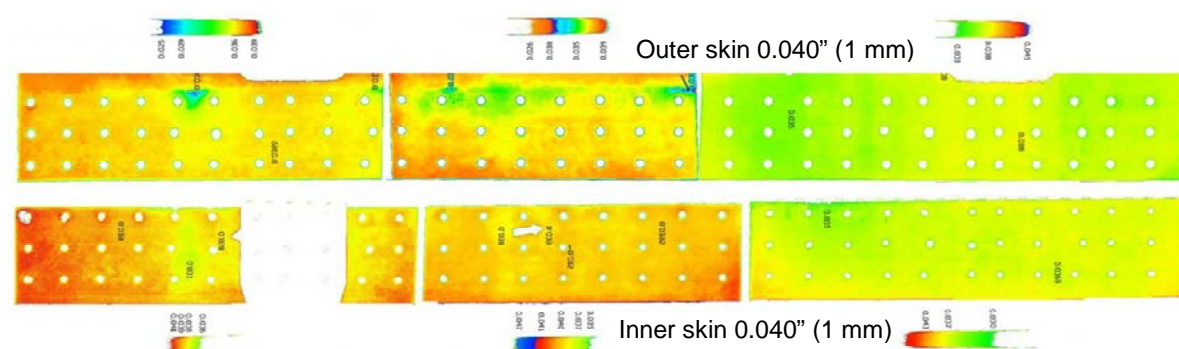
Skin thickness loss and cracked rivets – Figure 27-3 shows X-ray inspection results for an intact and disassembled lap joint. The skins of the lap joint suffered only 3 – 4% combined thickness loss yet 43 of the 93 rivets in the joint, a total of 47%, were *subsequently* (during teardown) found to be fractured, including a larger diameter replacement rivet in the middle row. Fractured rivets were those that easily broke into two during teardown of the joint (shop heads machined off and rivets pressed out).

(a) Rivet condition: Yellow – fractured.

(b) False-color digitized X-ray thickness loss (calibration ramps adjacent to sections).

Figure 27-3: X-Ray Inspection Results for (a) Intact and (b) Disassembled Joint.

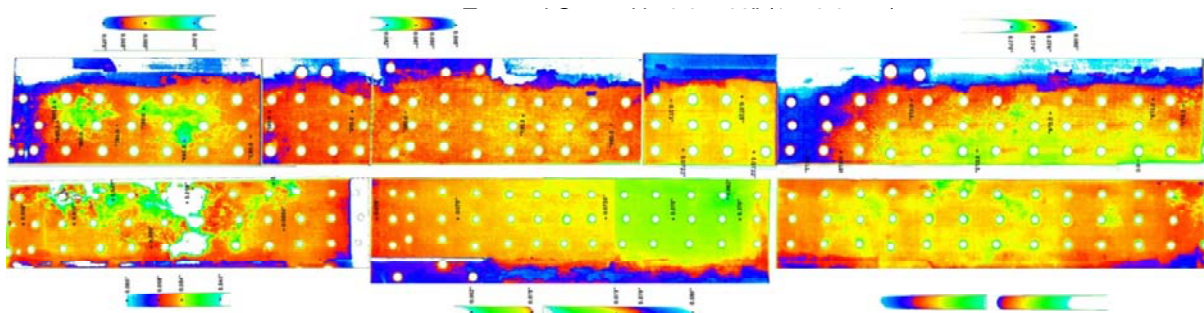
(a) Rivet condition: Red – Failed-in-place, Yellow – Fractured, Blue – Replaced.

Tapered Inner skin 0.06-.08" (1.5-2.0 mm)

(b) False-color digitized X-ray thickness loss (calibration ramps adjacent to sections).

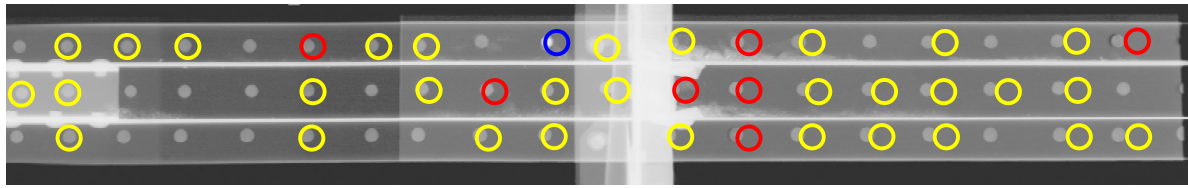
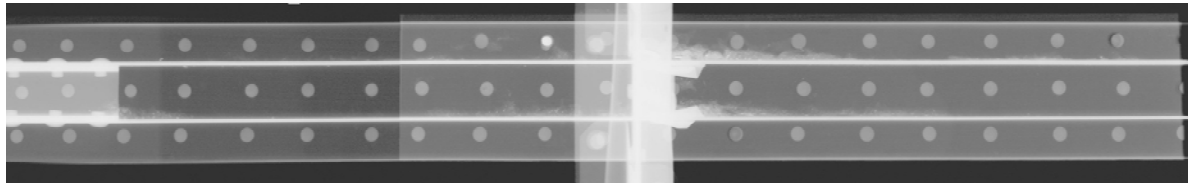
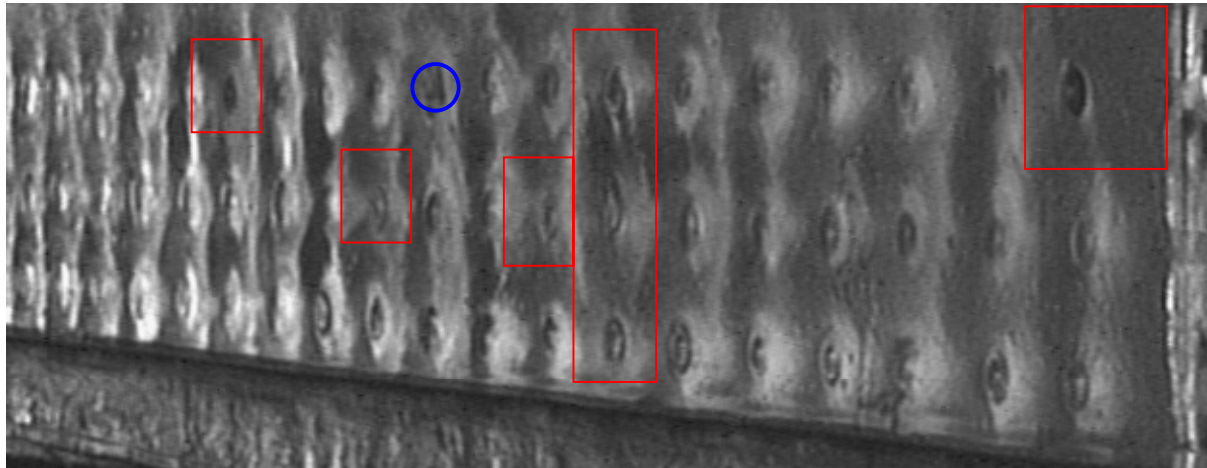
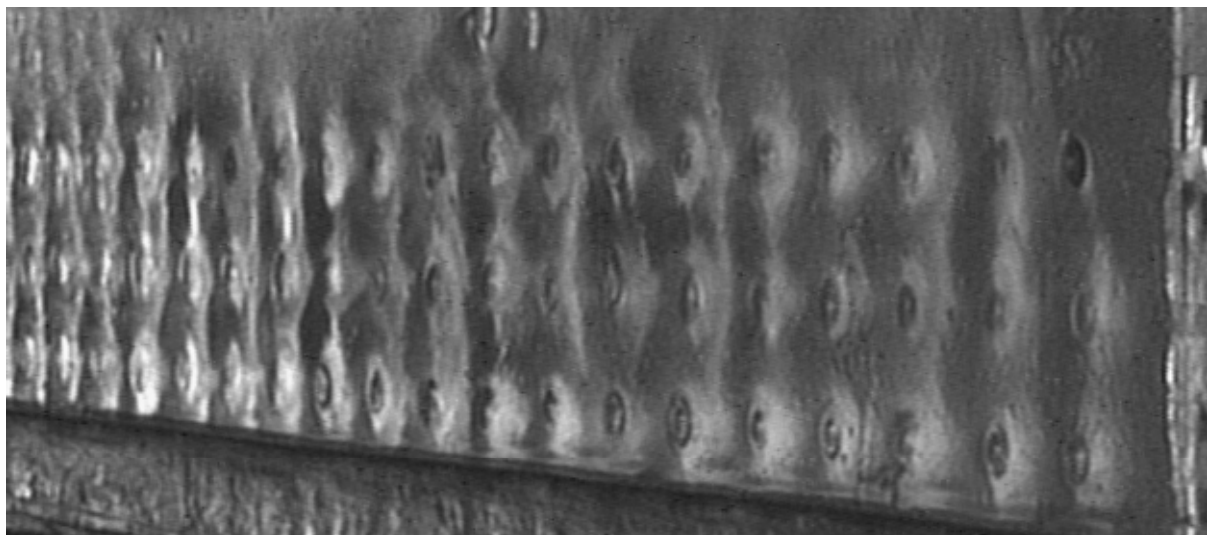
Figure 27-5 provides a closer assessment of the fasteners at the right end of the joint shown in Figure 27-4. The key for the colored circles applied to the X-ray image of the joint in Figure 27-5(a) is:

- Red – cracked around base of rivet head or head missing.
- Yellow – partially cracked.
- Blue – replacement for previously failed rivet.

(a) Rivet damage assessment on X-Ray of intact joint.

(c) Replaced rivet (blue circle), fractured rivets (red).

(d) DAIS view of LH end of lap joint (same as 'c').

Figure 27-5: DAIS and X-Ray Images of Left End of Joint (Figure 27-4) Showing Failed Rivets *In Situ*.

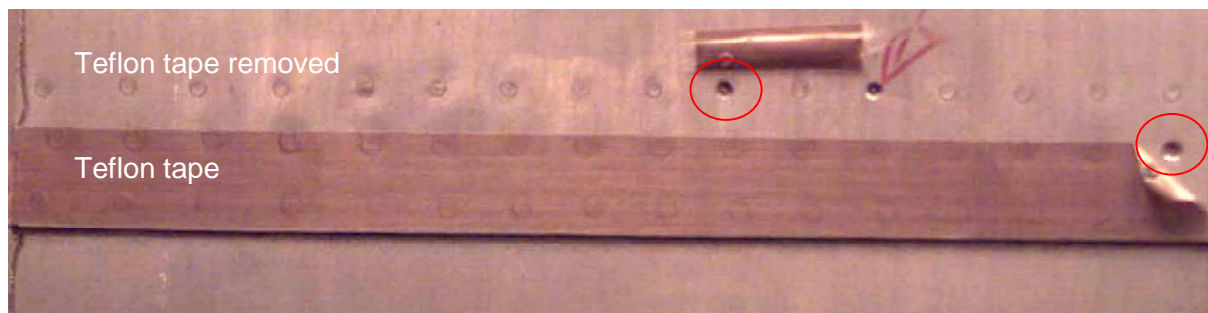
Figure 27-6 shows an unpainted longitudinal lap joint. One rivet head in the top row was missing (arrow) and this visible damage contributed to the selection of this joint for study. An automated eddy current scan of the joint was carried out before teardown. Scanning of the entire intact joint required the application of Teflon tape to prevent wear of the eddy current probe. After the scan the tape was peeled off, and this resulted in two additional rivet heads being released (circled). Observation of the parts of these two failed rivets showed that they had cracked and ultimately failed owing to the force created by corrosion pillowing. There was only minor corrosion on the rivet surfaces.

Figure 27-6: Corrosion Pillowing Induced Failure-in-Place of Rivets Discovered by Tape Peel.

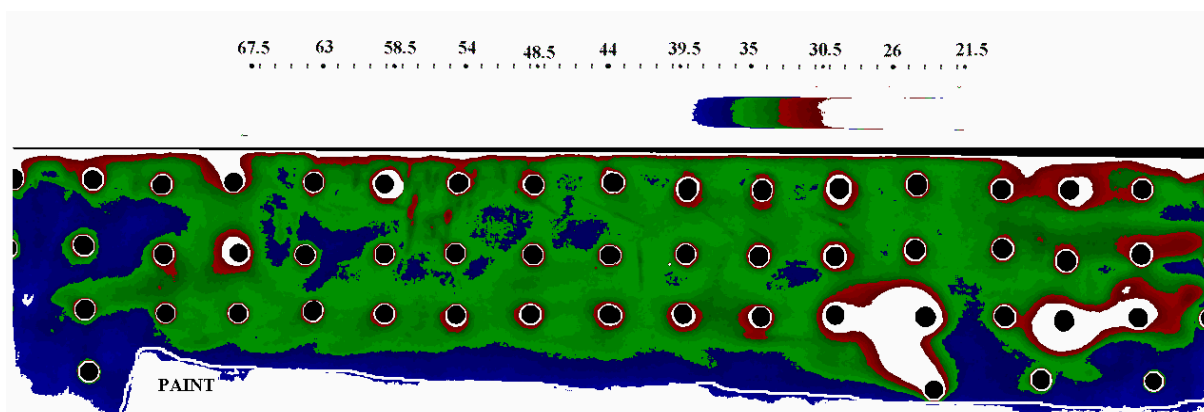
- 3) Drilling out rivets always has the potential to cause elongated fastener holes. Figure 27-7 gives an example where not only were the fastener holes enlarged to the maximum size but they were almost all elongated. In addition, the skin was found to be corroded and the removal process thinned the skin by up to 37% (white areas). In this case it was deemed appropriate to attach a new skin to this damaged skin, match-drilled into the same elongated fastener holes. On the other hand, one might well consider that enlarging the replacement skin sheet size and also shifting the joint to the next stringer on the remaining original sheet should eliminate such a compromised joint.

Figure 27-7: Elongated Holes from Rivet Removal and Skin Thinned by Corrosion Removal.

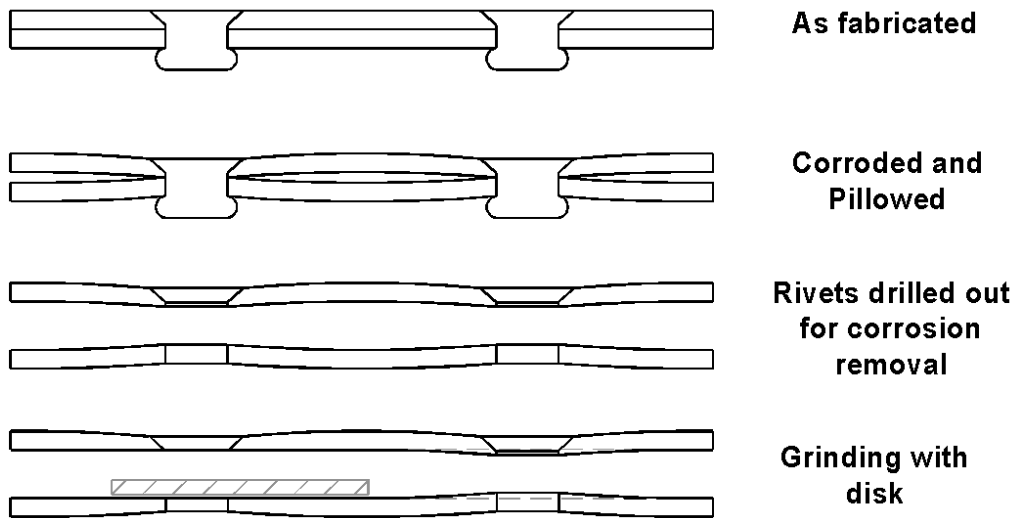
As shown schematically in Figure 27-8, corrosion product removal by grinding, i.e., with rigid abrasive power tools, can cause serious damage to the faying surfaces. This damage could cause high stress concentrations, increasing the risk of premature cracking. Also, if cracks have *already* initiated at the faying surfaces owing to pillowing forces (as predicted by Finite Element Analysis and found during teardowns) then grinding could smear the cracks closed and obscure them from visual and X-ray inspections. Thus faying surface corrosion products are better removed by chemical cleaning.

Figure 27-8: Scenario Showing how Grinding Could Remove Excessive Amounts of Material from Around Rivet Holes.
